Manhole Inspection Summary

Manhole # S33CC_011MH

Insp Date: **5/14/09 10:03 AM**

Location Address: **901 TYSON ST**

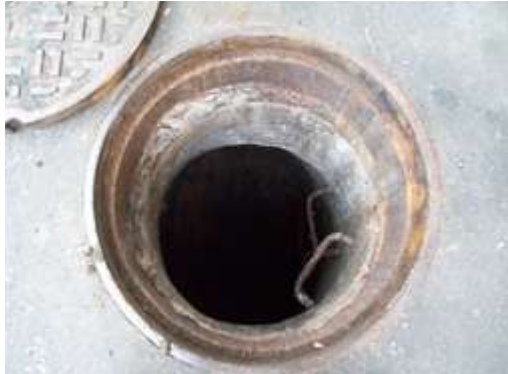
Defect 3

Condition: ☐ Sound ☐ Cracked ☐ Root Intrusion ☒ **Loose Brick** ☐ Deteriorated

loose bricks frame adjustment

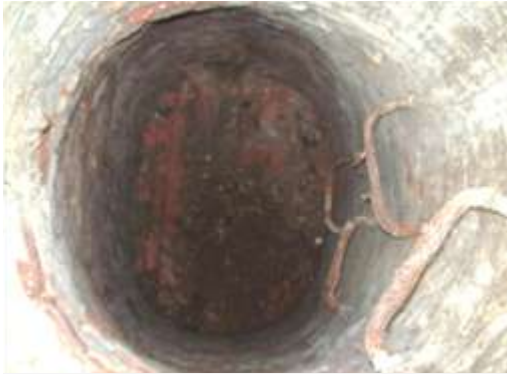
Defect 2

Condition: ☐ Sound ☐ Cracked ☐ Root Intrusion ☒ **Loose Brick** ☐ Deteriorated

loose bricks barrel

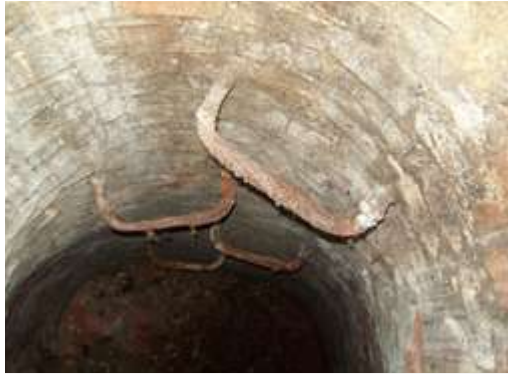
Defect 1

Count: **4** Missing: **0** ☒ **Corroded**

☒ **Evidence Of Surcharge** Depth: **2** (ft.) ☐ Active Surcharge Present

CORODED STEPS and evidence surcharge

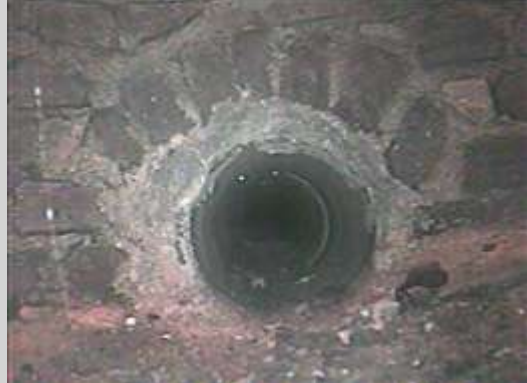
12 O'Clock Outflow

8 in. Circular Gravity Sewer
Pipe Out @ 12 O'Clock

Infiltration: **None** Pipe Seal Cond: **Sound**
